RENOVATION & EXPANSION PROJECT – **CONSTRUCTION PHASE / Month 11**

Clerk of the Works Report No. 21 – February 28, 2026

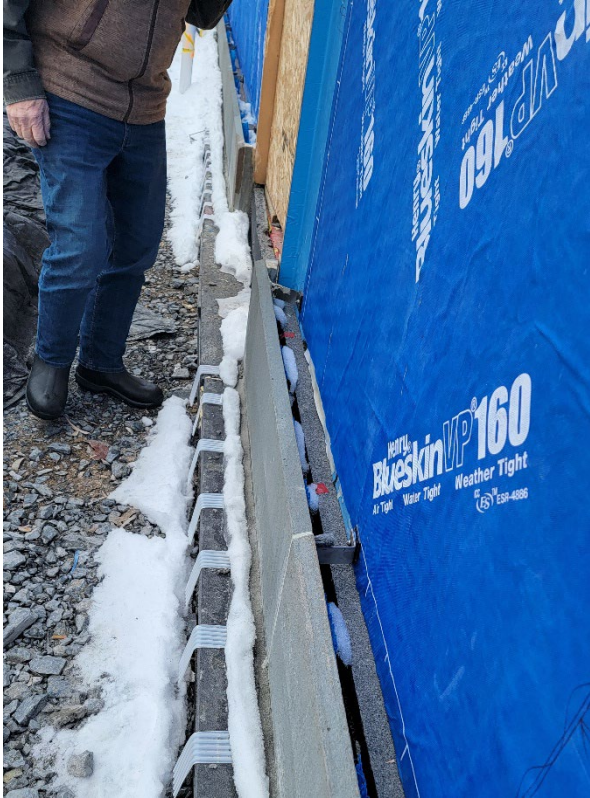
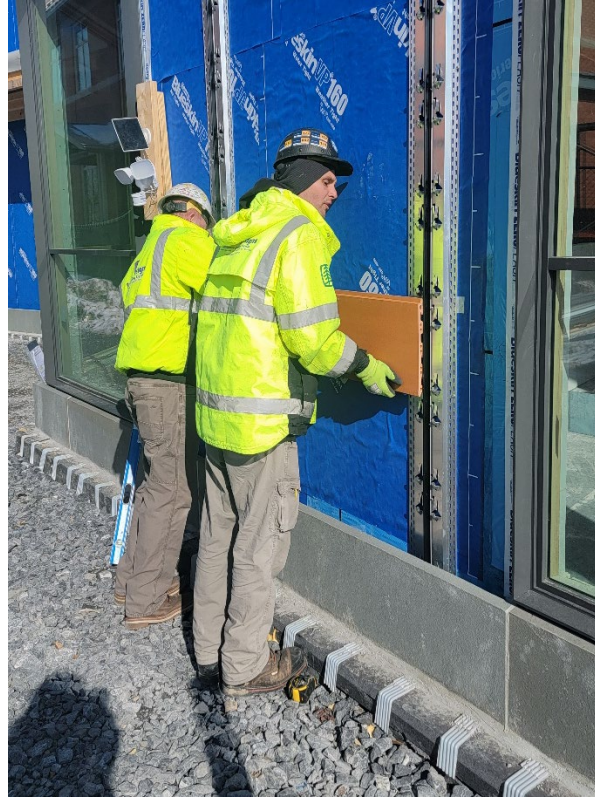
BLUESTONE damp course (base course) in place. **TEST FIT!** EDI crew hangs the first piece of terracotta. Perfectly level, plumb, and true! March 05, 2026.

- Triangular reinforced fiberglass enclosures marching around the base of the building are gone. These tents were miniature greenhouses required for Tedesco to set the bluestone base course in mortar which must be protected from frost for a minimum of 24 hours. That work is now complete. **PHOTO page 4**
- Activity on the roof terrace and high roof as well. If you sense the roof terrace parapet wall looks lower than what you had become accustomed to seeing, you are correct. ReArch has cut the height by about 13" – at their own cost. The original design had been detailed higher than the minimum requirement of 42", and no one on the team was happy with the resulting "cut-off" of view. The results are quite noticeable. Our thanks to ReArch for voluntarily making this adjustment. **PHOTO page 4**

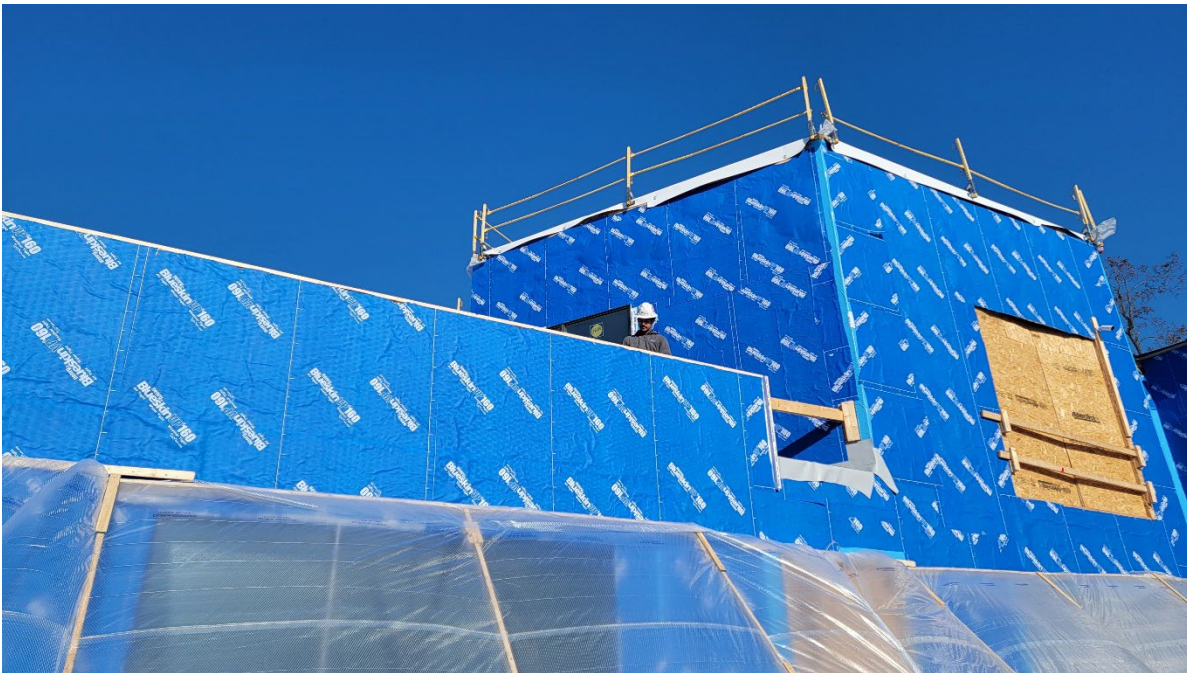
ROOF TERRACE parapet wall, reduced in height.

- **ReArch’s self-performance crew** has handled many complex, limited scope tasks under the direct supervision of Ben Scribner. These vary: installing window extrusions, re-setting the height of the roof terrace parapet, multiple re-framing tasks in the 1924 building, forming and pouring pads for mechanical equipment. They are flexible and broadly experienced, saving us additional costs by avoiding adds to subcontractor scopes of work or schedules.

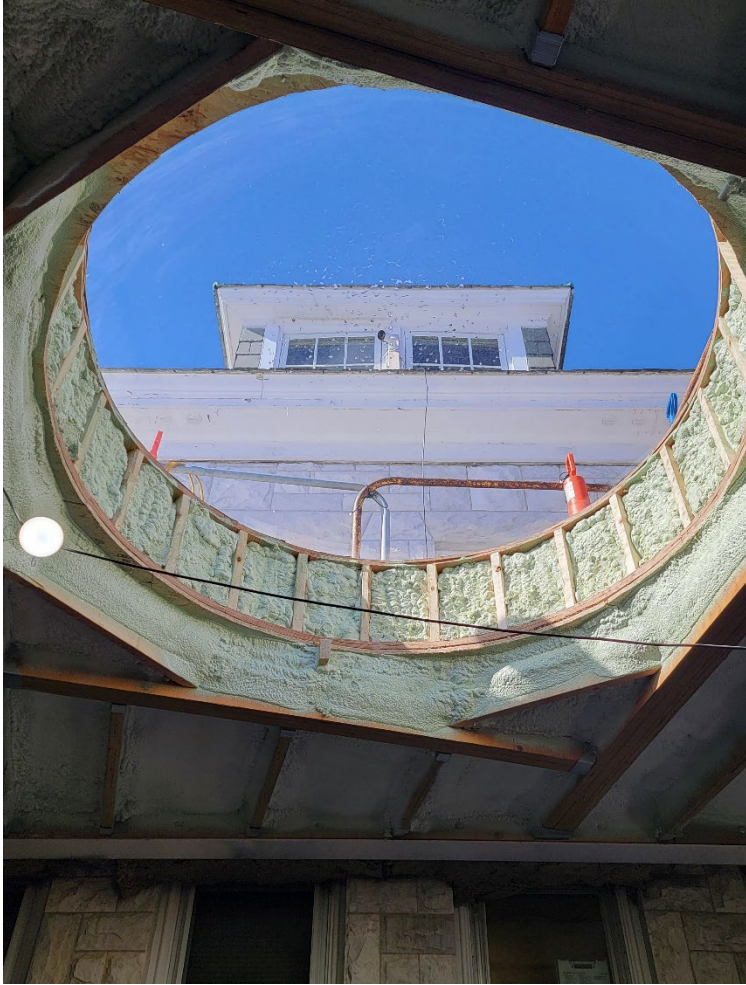
Atrium triple pane dome skylight in place.
1924 building east dormer perfectly framed above.

- **A.C. Hathorne Roofing** is responsible for the installation of the large triple-wall domed skylight over the south atrium. It was placed on February 19th and provides an amazing amount of light to the interior of this soon to be active public atrium. As with most exterior openings, the view through them frequently remains a hidden secret that once unveiled becomes a picture frame, capturing a delightful sliver of the immediate world outside. **PHOTO Page 6**

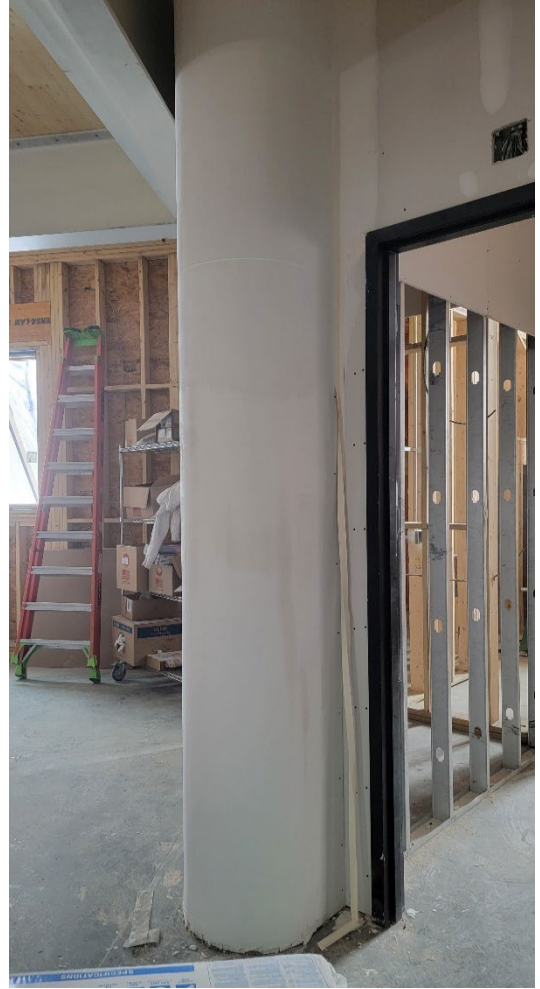
Community Room: Optimum's skill evident.
Difficult radiused gypsum board detailing!

- **Optimum**, our light gauge metal framers and sheetrockers have nearly completed both floors of interior partition definition and have shifted gears to interior gypsum board installation as in-wall utilities are completed. Their work is of excellent quality on some extremely challenging applications (tightly curved walls). **PHOTO Page 6**

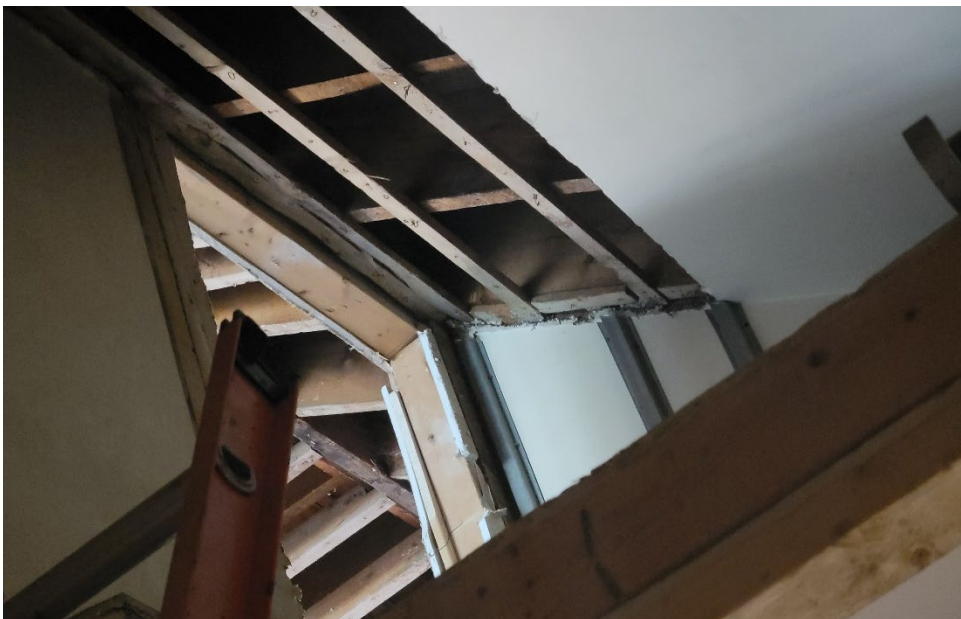
Another framing puzzle to un-snarl, attic of the 1924 building and compromised roof rafters requiring replacement. Engineering Ventures, our structural engineer has been extremely responsive to each situation with a rapid practical solution.

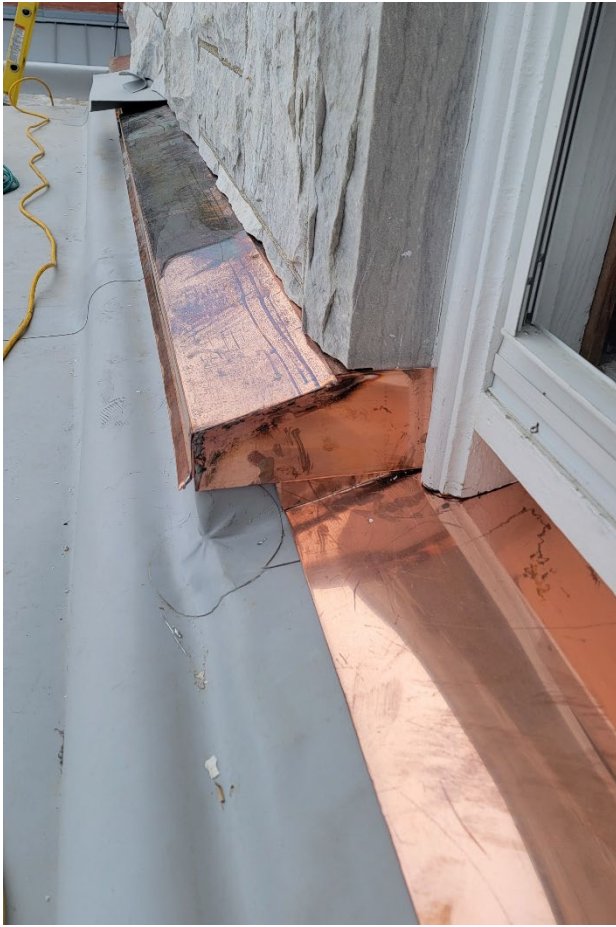
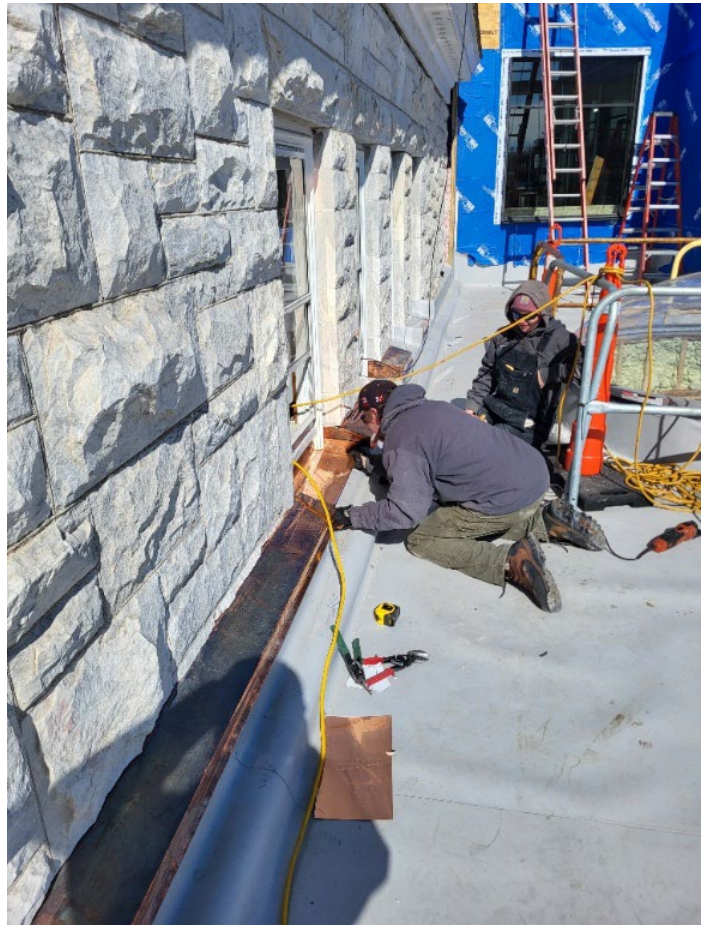
Copper flashing details at expansion joint between 1924 building and roof terrace. AC Hathorne team at work carefully creating and fitting pieces from flat stock.

Expansion joint assemblies “allow for movement caused by thermal expansion/contraction, wind sway, seismic events, or loading. They prevent cracking, buckling, and structural damage by separating materials, allowing them to shift independently”. Our versions of these complex assemblies are many and varied, requiring extensive experience and technical skill to be successful. They are also a critical part of our building envelope “score” for tightness and Energy Standards compliance and will directly affect our rebates from Efficiency Vermont.

- **A.C. Hathorne** is also responsible for all membranes on the roof surface are currently IN PLACE although their terminations and transitions are still in process, including parapets on low and high roofs. Hathorne has moved on to the challenges of expansion joints. At every condition around the 1924 building, flexible but waterproof joints must be created to bridge the intentional gap between 1924 and 2026 construction. **PHOTOS Page 7**

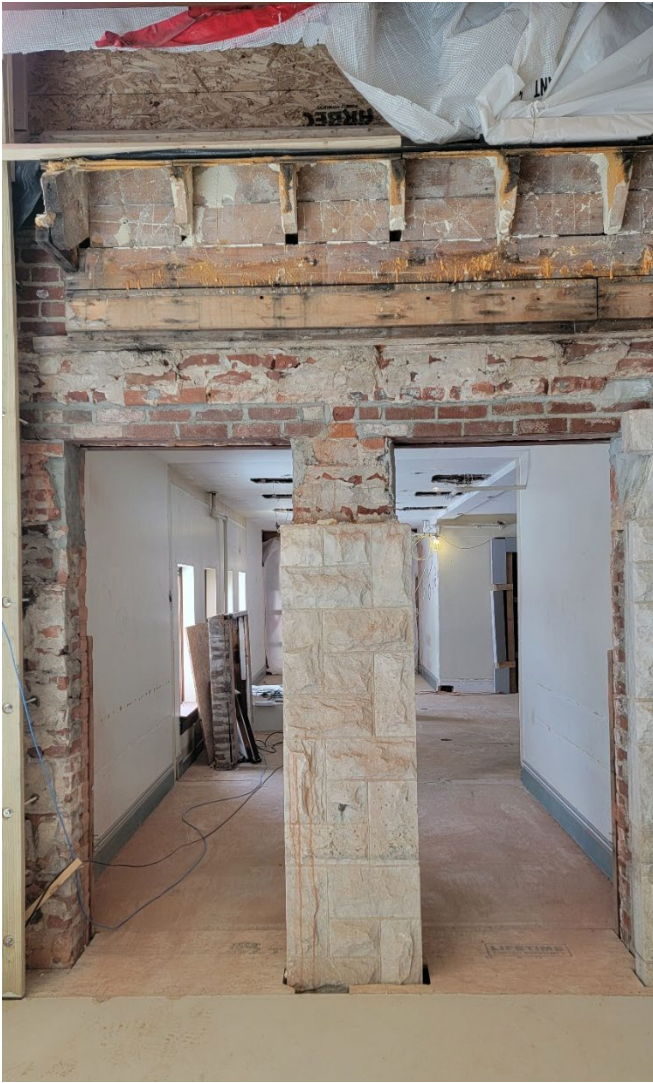
This second-floor double passageway from the new adult collection into the 1924 reading room and study rooms was designed to be at the same floor level. After demolition of the 1988 addition, we found openings had been blocked off, marble units demolished, all rafter tails and classic soffit detailing removed. This must all be painstakingly replaced. We will extend the rafter tails, re-use masonry units salvaged on site, and our D/B team has found a local woodcrafter (Treehouse Hardwoods) capable of replicating historic trim profiles, a rare talent in 2026.

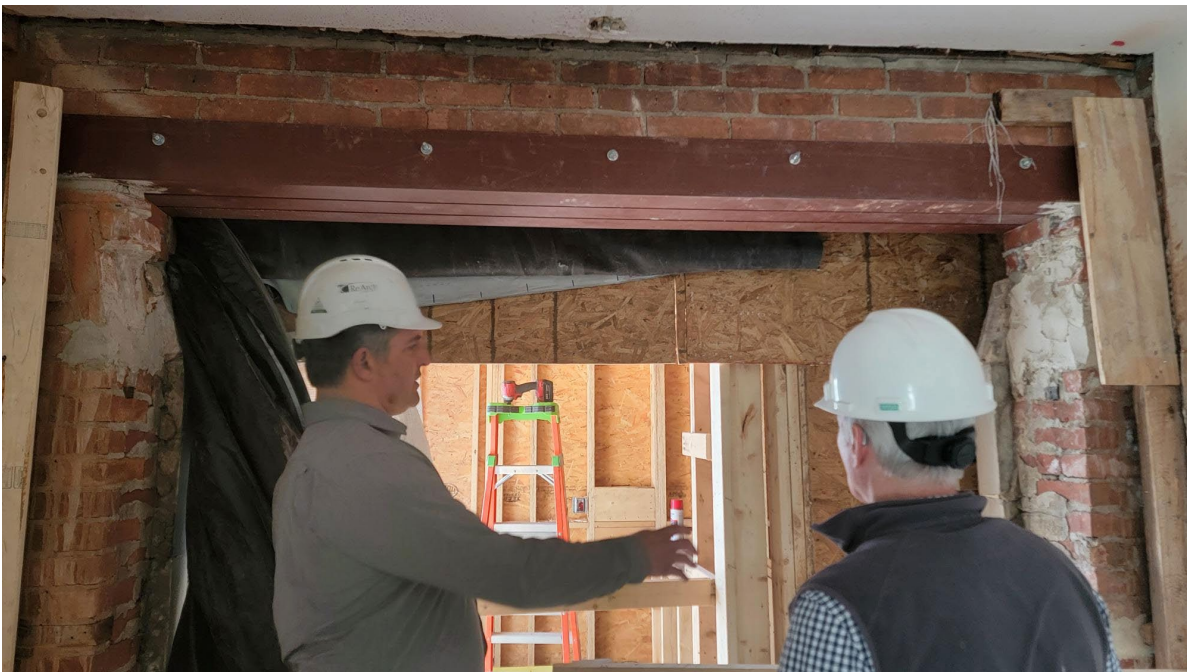
Below, Tim Duff (WLA architect) and Ben Scribner (ReArch superintendent) puzzle through options for yet another “concealed condition”). This is a test of true teamwork. So far our project’s end results have benefitted handsomely.
